U.S. ENVIRONMENTAL PROTECTION AGENCY  
POLLUTION/SITUATION REPORT  
American Zinc Products Fire - Removal Polrep  
Initial and Final Removal Polrep

**Subject:** POLREP #1  
Initial and Final  
American Zinc Products Fire

Mooresboro, NC  
Latitude: 35.1916330 Longitude: -81.8488390

**Date:** 5/1/2019

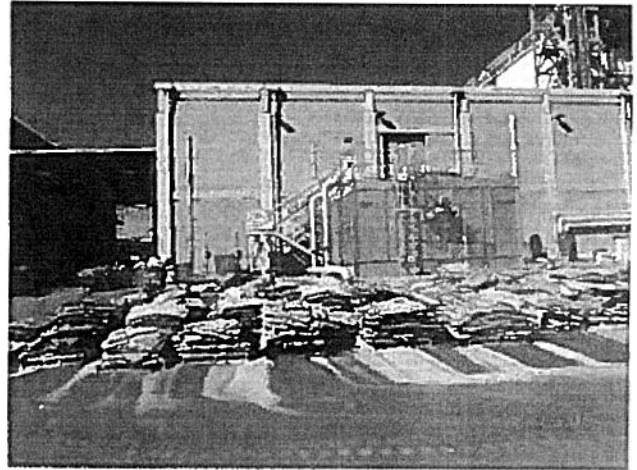
The furnaces were designed to handle 16,500 pound bundles of zinc plates, stacked and placed inside (Pictures 1, 3-4). The zinc is melted and poured into molds for 25-pound and one-ton ingots. The ingots are sold to the steel industry for galvanizing uses, erosion protection of steel, the construction industry and the automotive industry. HHMP will produce three products: prime western which contains 1% lead, continuous galvanizing grade which has 1.5% aluminum and a special high grade which is 99% zinc.

Picture 4 – Zinc Sheets waiting to be processed

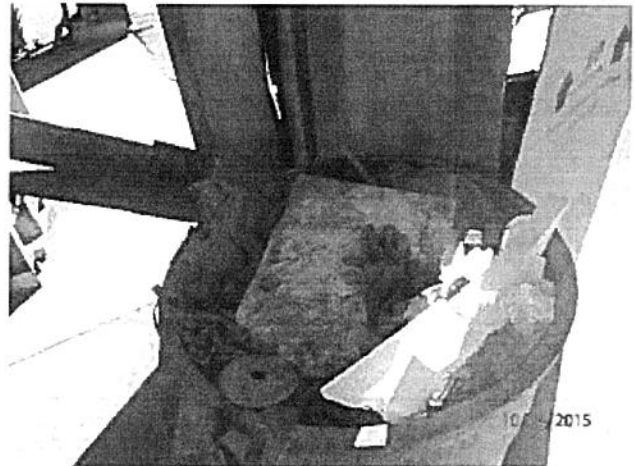
Picture 6 – Rail Yard hazardous waste debris open container

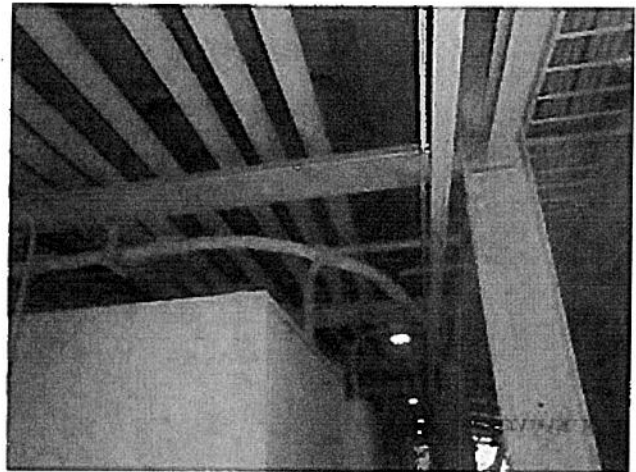
Picture 11 – Rail Yard piping to Blower System for silos

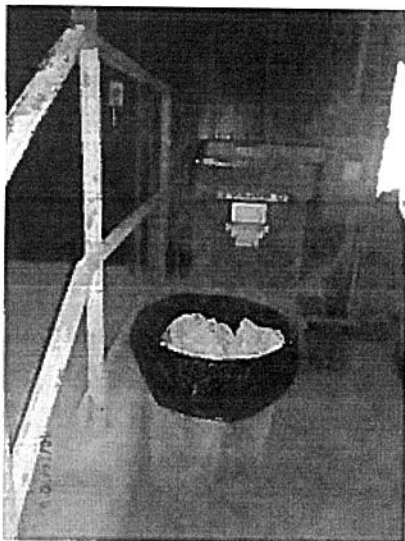
Picture 14 – Rail Yard unloading area trash can with WOX contaminated tyvek

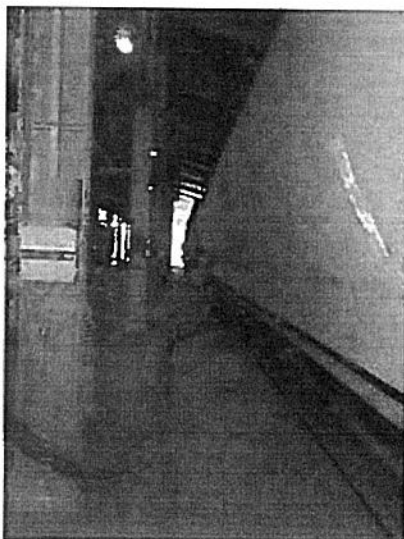
Picture 15 – Rail Yard incoming railcar unloading area

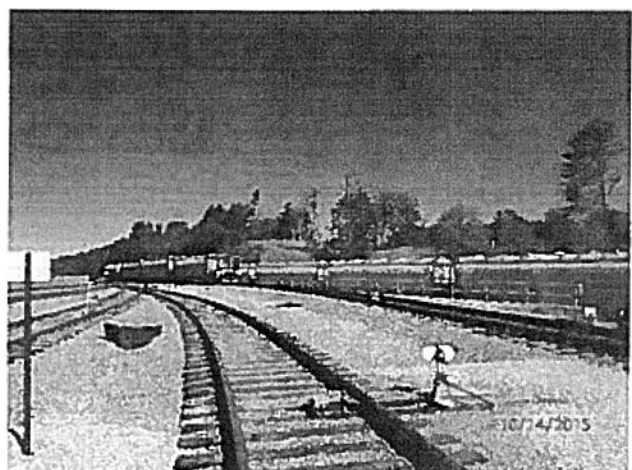
The waelz oxide (WOX) dust is brought in via pressure differential railcars to the WOX Unloading Area (Pictures 2, 5, 8, 17-19). This area consists of four converging rail lines that move the cars into the unloading area, and five rail lines used for storage of the incoming and outgoing railcars. Because of the restricted access that requires respirators, at the time of the inspection only EPA inspector Paula Whiting entered the WOX Unloading Area.

Picture 18 – Rail Yard storage tracks

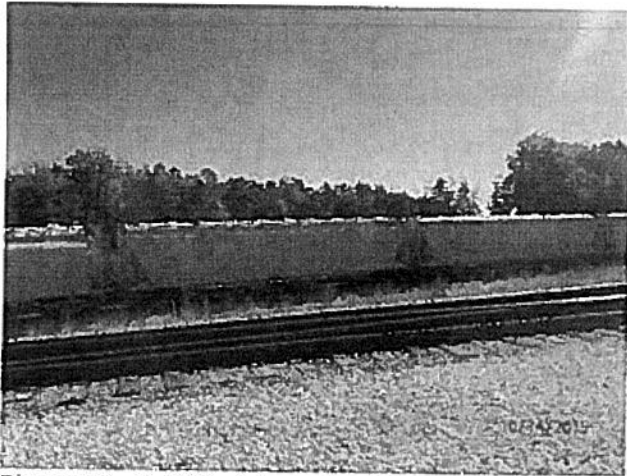
Picture 19 – Rail Yard storage tracks

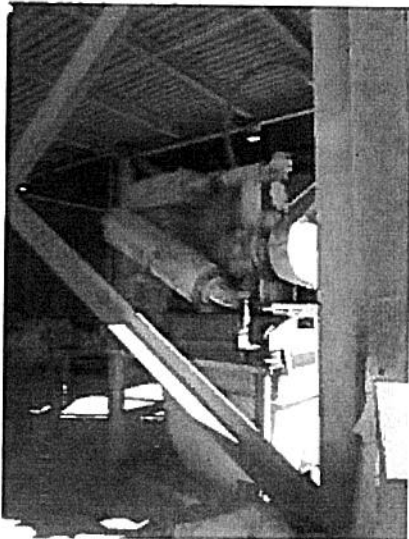
The inspector also observed a high vacuum system to collect the released WOX dust (Pictures 20-21). Mr. Jarrold explained that the dust from the vacuum system was not a waste and was sent to WOX washing. Spent hoses contaminated with WOX dust from the blower system were observed on a pallet beside the storage tracks (Pictures 7-9). A gray trash can that contained used Tyvek suits was located near the stairs to the blower system (Pictures 14, 16), and a gray trash can that contained contaminated debris from unloading WOX was located near the high vacuum system (Picture 6). Both containers and the spent hoses were open and unlabeled. Mr. Jarrold explained that the used Tyvek suits are considered regular trash and not hazardous waste because they were not contaminated with the WOX dust. However, the trash can is located inside the WOX Unloading Area without a lid and the Tyvek are worn during the unloading process.

Picture 21 – Rail Yard high vacuum system for WOX

dust

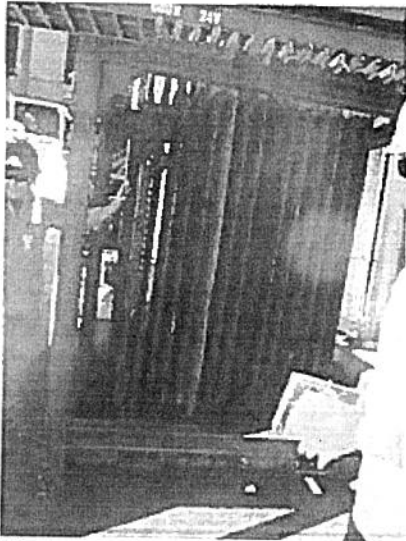
Picture 25 – Electro-winning spent aluminum plates

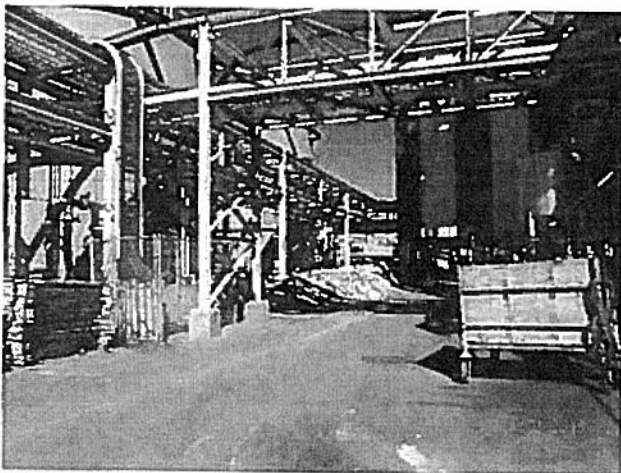
Picture 27 – Cellhouse zinc clean out material

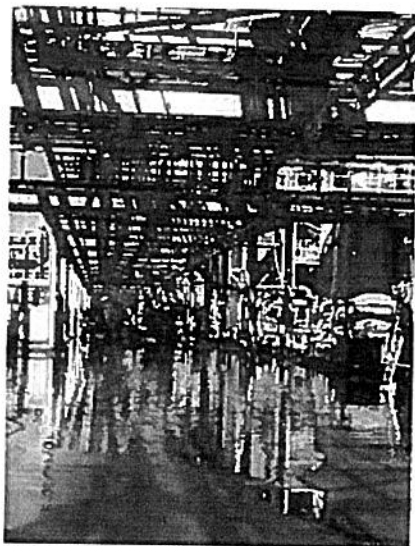
Picture 33 – 100 Area flooded from stopped drain

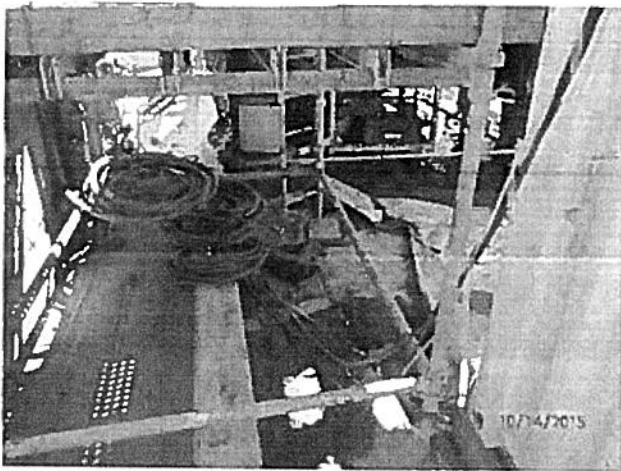
Picture 38 – 100 Area Reactor secondary containment with accumulated leach residue

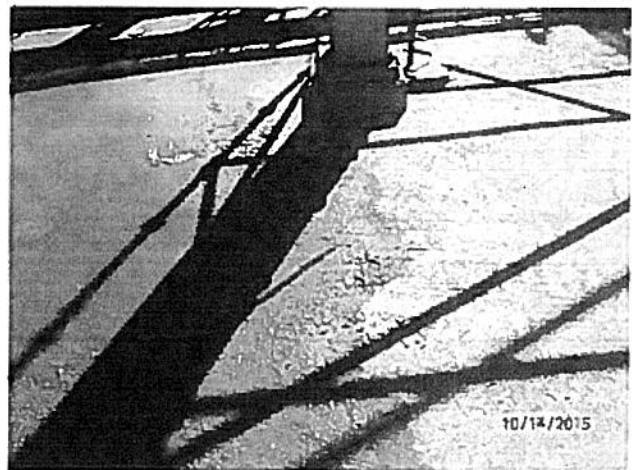
Picture 42 – 100 Area main secondary containment covered in unknown dust and mud

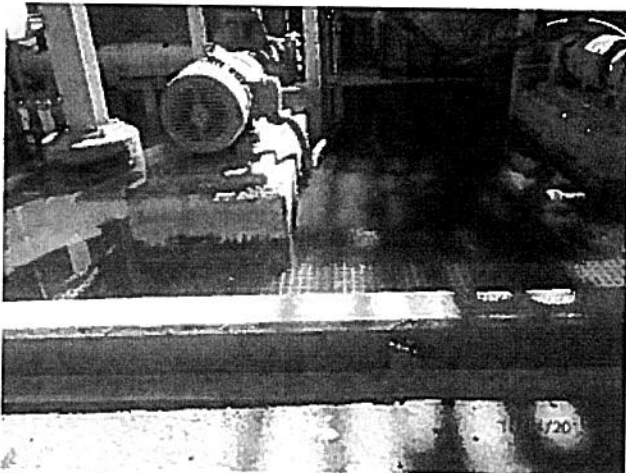
Picture 45 – Raffinate Area secondary containment with rainwater

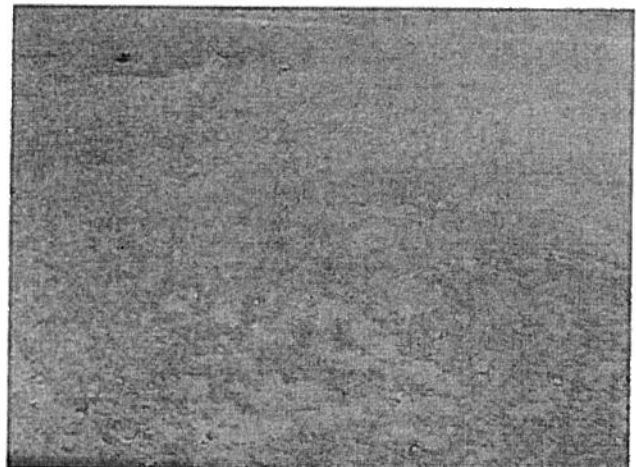
Picture 48 – Raffinate Area secondary containment with etched concrete under rainwater

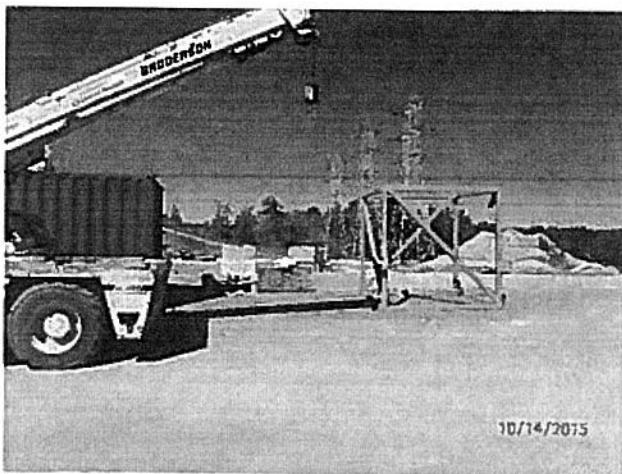
Picture 52 – Runoff area for depleted solution break

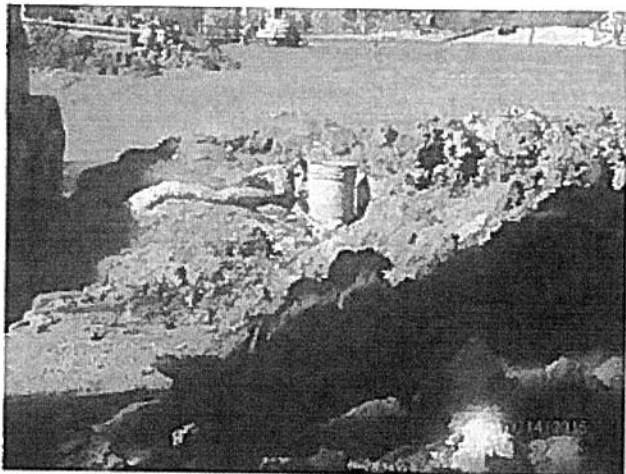
Picture 72 – Close up of Final Residue discharged to the ground

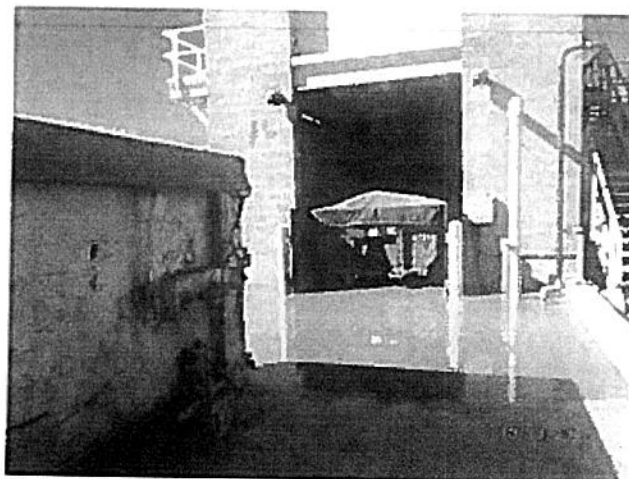
Picture 91 – Crude Press Area HW roll-offs

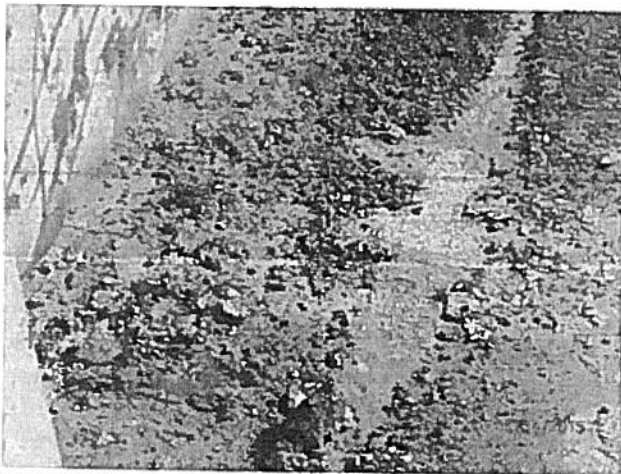
Picture 98 – Crude Press Roll-off material released on the ground

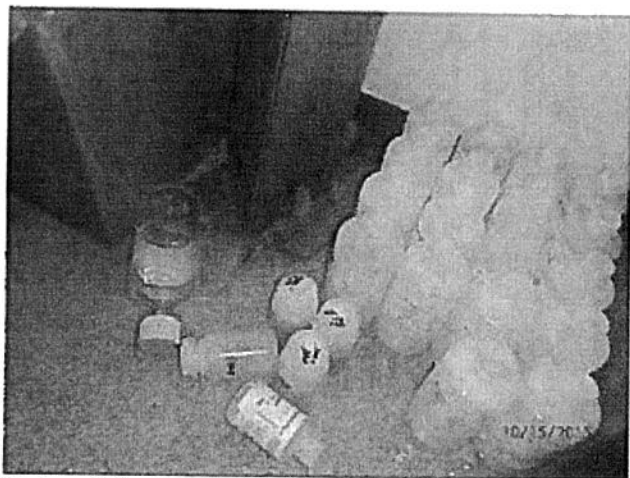
Picture 119 – Process Lab – organic solvent waste

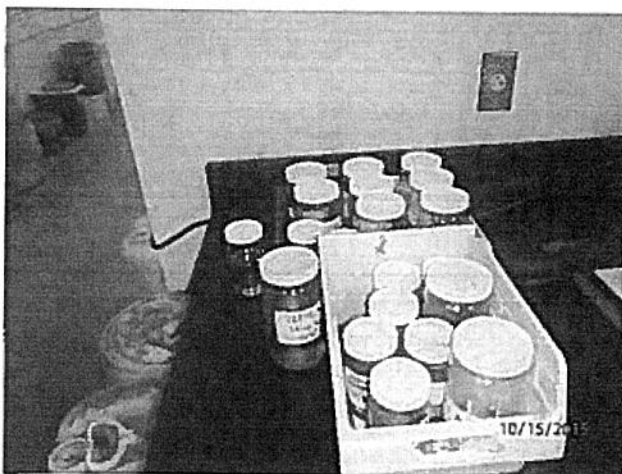
Picture 125 – Process Lab gallon jar of chromic acid waste open in fume hood

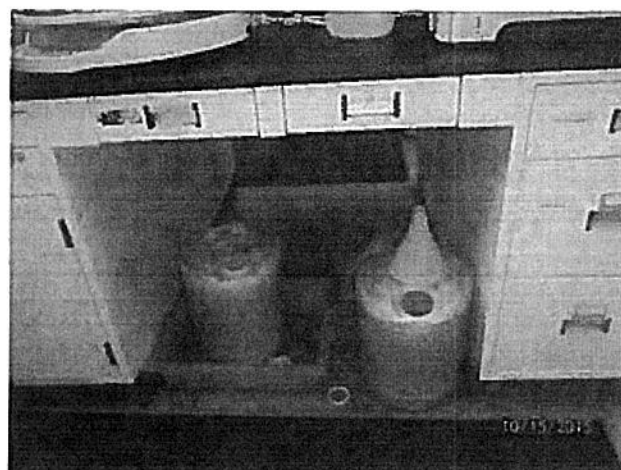
The inspectors observed white totes of diluent waste (Picture 121), white containers of organic material samples (Picture 122) and jars and totes of spent DEPHA (Pictures 123, 126) were to be recycled in the process were being stored along the walls in the lab.

Picture 123 – Process Lab jar of spent DEPHA

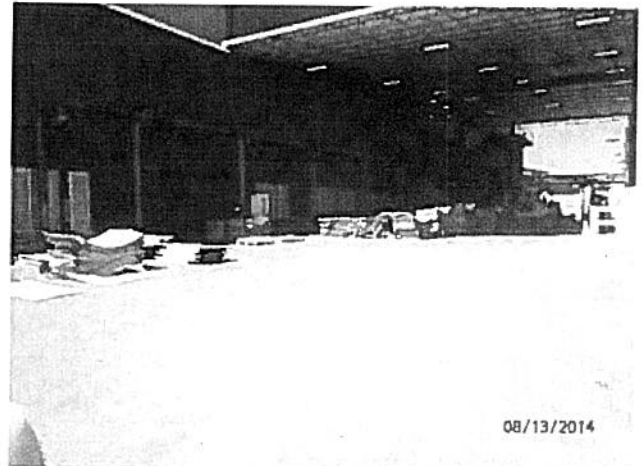
The inspectors passed through the 500 Area (furnace) and 400 Area (electro-winning (EW)). The inspectors observed stacks of zinc plates being dried prior to being placing in the furnace (Picture 5); five 385,000-gallon electrolyte storage tanks with high zinc concentrate mixed with sulfuric acid solution (Picture 6) and the furnace baghouses (Picture 7). Mr. Harris explained that

The furnaces were designed to handle 16,500 pound bundles of zinc plates, stacked and placed inside (Pictures 5, 65). The zinc is melted and poured into molds for 25-pound and one-ton ingots. The ingots are sold to the steel industry for galvanizing uses, erosion protection of steel, the construction industry and the automotive industry. HHMP produces three products: prime western which contains 1% lead, continuous galvanizing grade which has 1.5% aluminum and a special high grade which is 99% zinc. Across from the Area 500 are four baghouses that capture the zinc dust from the furnace.

Picture 5 - Area 500 Furnace with stacks of zinc plates

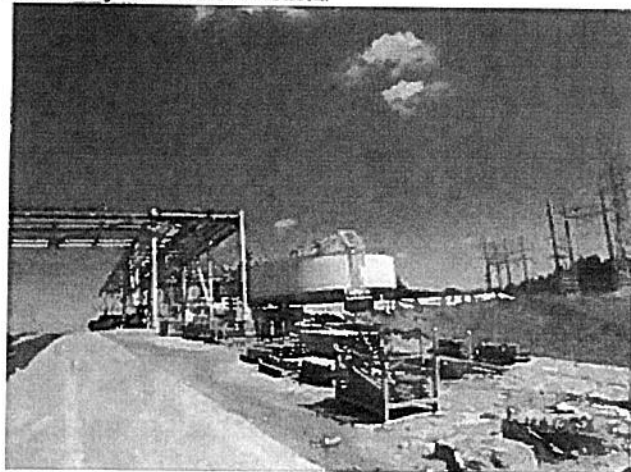
The WOX clarifiers mixes the WOX with water and sulfuric acid. The inspectors observed the clarifiers were open to the elements. The clarifiers and two stainless steel acid tanks were inside the secondary containment area (Pictures 10-11). At the time of the inspection, the gypsum clarifier (Pictures 17, 23), located downhill from the WOX clarifier, were experiencing blockage problems and were being pumped into the WOX clarifier secondary containment (Pictures 12-13). The inspectors observed that the secondary containment walls of the WOX clarifier had leaking cracks waiting to be repaired and areas that were newly resealed (Pictures 14-16). Mr. Harris explained that the secondary containment was designed to be a 10 to 14 day storage for process use.

Picture 10 – WOX Clarifier

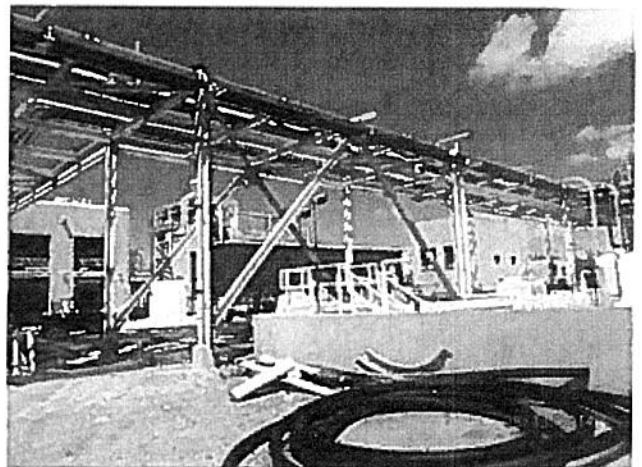
The inspection of the Area 100 started at 100A - final zinc discharge building (Picture 22). This building collects the high zinc residue from the process, drops it onto the ground and the residue is frontloaded into piles in the secondary containment/runoff area (Pictures 18, 21). The building was originally designed to drop the residue into the roll-offs but the chutes did not properly align to deposit the residue into the roll-offs, so the roll-offs were removed. Once the high zinc residue is frontloaded into roll-offs, the containers are shipped to Horsehead in Palmerton, PA.

Picture 18 – Area 100A – Final High Zinc

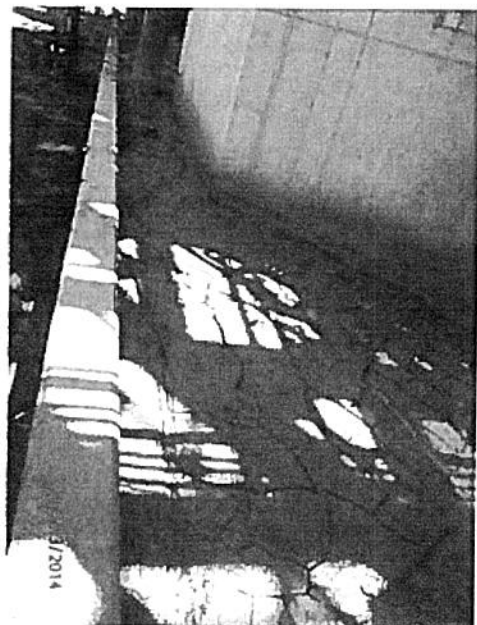
Picture 29 – Area 100 Leaching WOX mixture released to the secondary containment

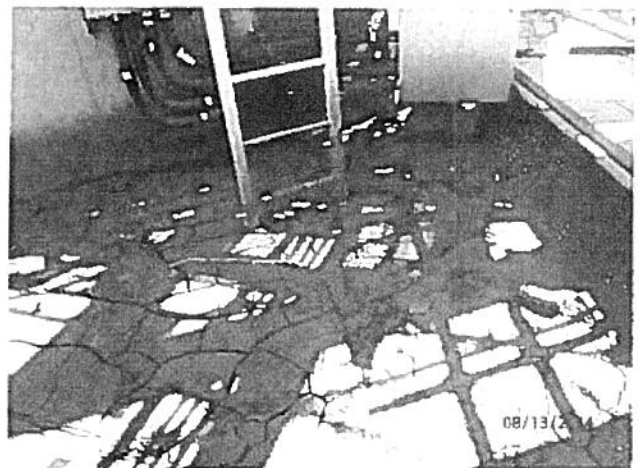
Picture 30 – Area 100 Leaching WOX mixture released to the secondary containment

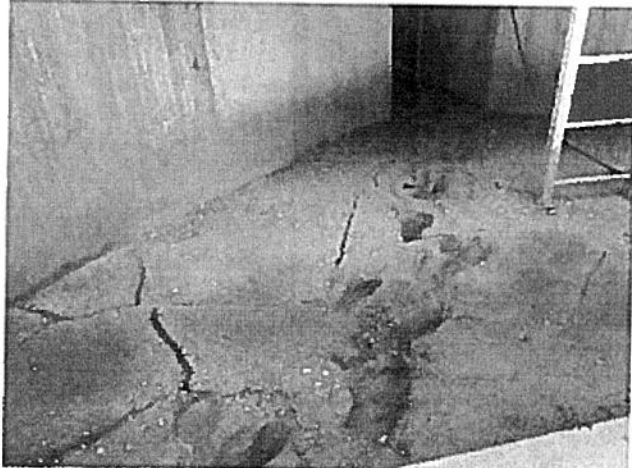
Picture 31 – Area 100 Leaching WOX mixture released to the secondary containment

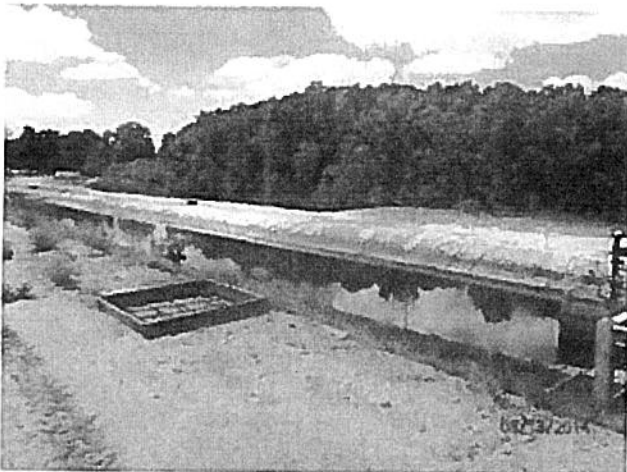
The Area 200 contained the processes for zinc electrolyte solution phase separation (Picture 39). The inspectors observed black tanks used to separate water from the zinc, acid and organic solvent solution. Behind the tanks were the process ponds, a maintenance pond, and the West Storm Water Pond (Pictures 40-43). Mr. Harris explained that the zinc raffinate goes, via a green pipe, into the open process ponds. Next was a maintenance pond with orange water. The last pond was the West Storm Water Pond with geese deterrents. This pond was lined for acidic organic solutions and contained acidic water with a red algae bloom. Mr. Hoenecke explained that this pond acts as a catchall from the process areas. The process water came from tank failures and coating failures in the process tanks.

Picture 43 – West Stormwater Pond with geese deterrent

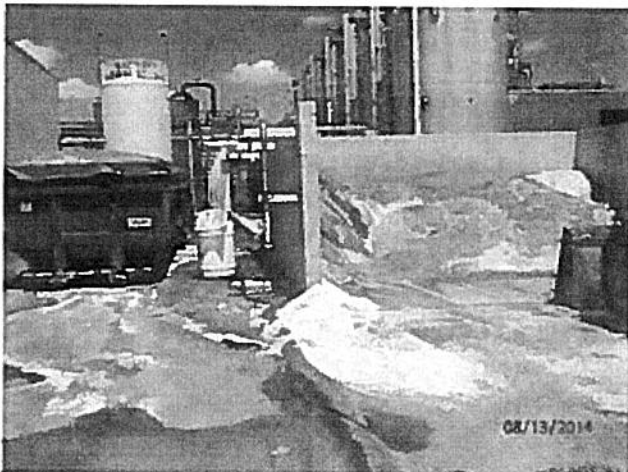
Picture 45 – Carbon Filter Tank lead contaminated carbon

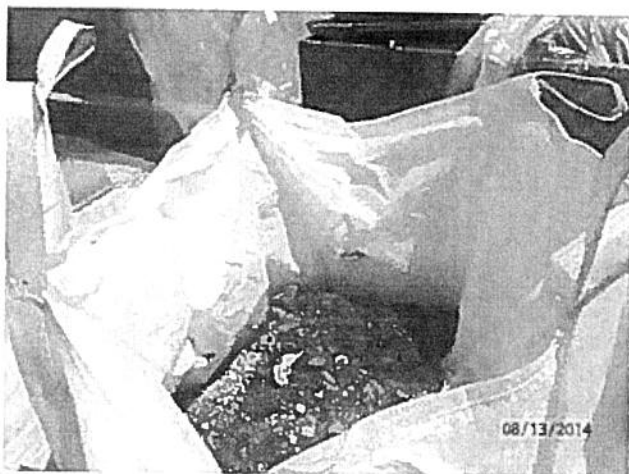
Picture 51 – Carbon Filter Tank supersaks of unknown media

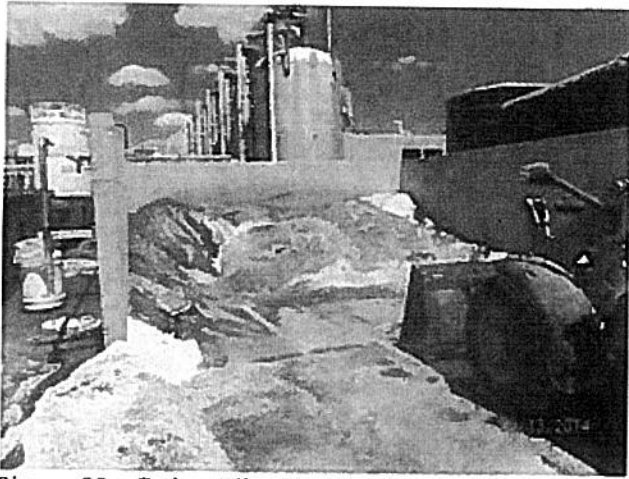
Picture 55 – Carbon Filter Tank lead contaminated carbon

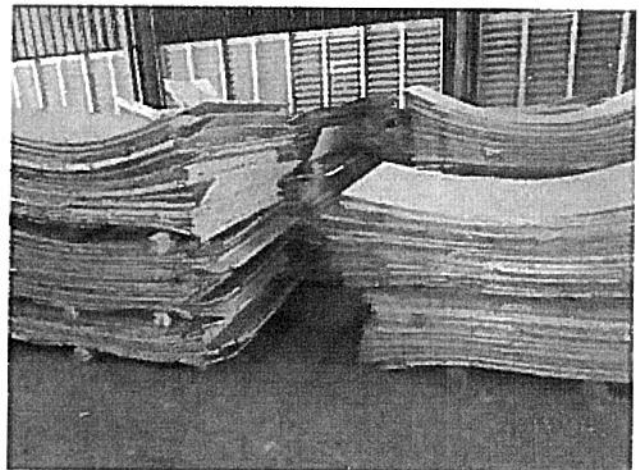
Picture 65 – Area 500 Furnace stack of zinc plates

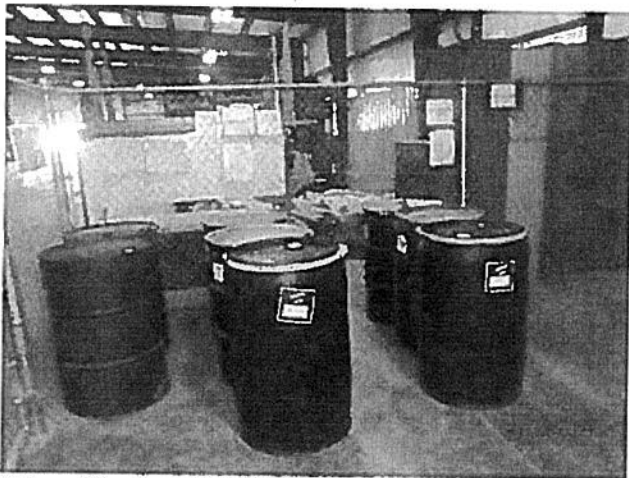
Picture 67 – Area 500 HWSA used oil drums

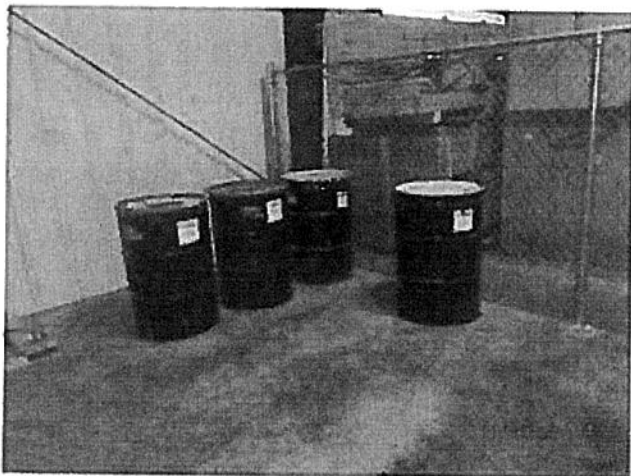
Picture 68 – Area 500 HWSA hazardous waste drums

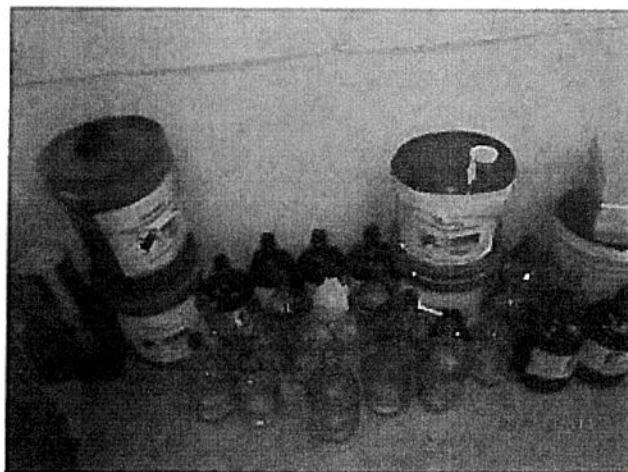
Picture 71 – Lab RCRA empty bottles

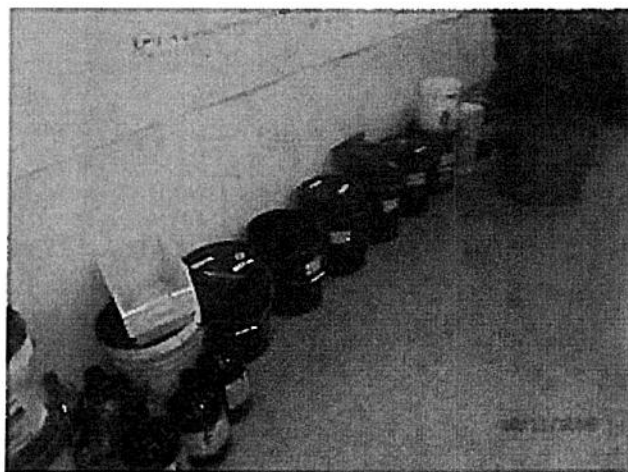
Picture 72 – Lab RCRA empty bottles

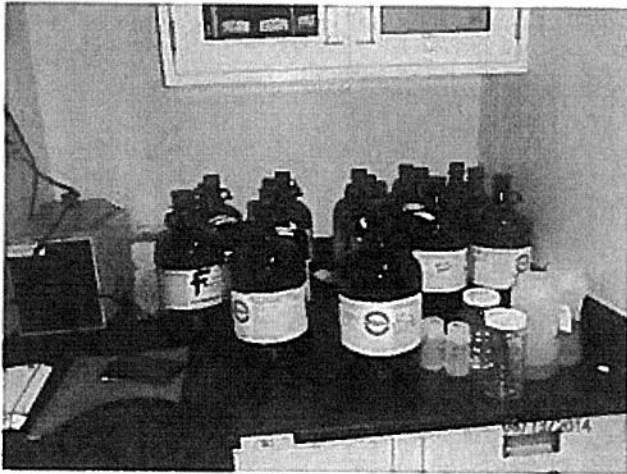
The second lab distilled used trichloroethylene (TCE). The inspectors observed a counter with used TCE bottles (Picture 73). The technician explained the used TCE was considered "waste in process" and would be recycled when it was no longer usable. The inspectors advised that the lab technicians monitor the volume of used TCE on the counter and ensure that the volume stay under 55-gallons.

Picture 73 – Lab used TCE solvent recycling area

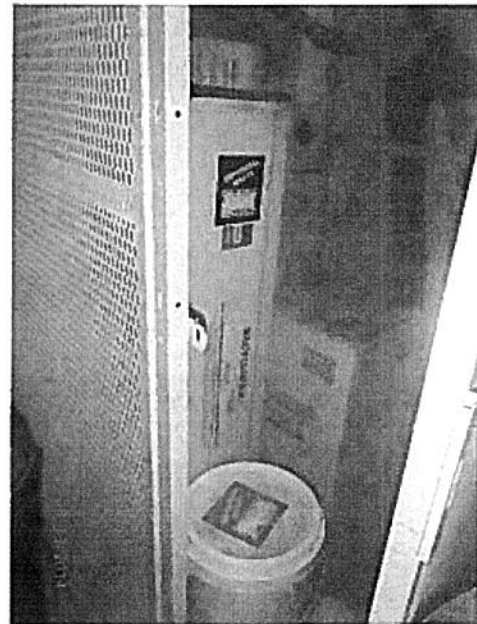
Picture 77 – Maintenance universal waste storage
